USER MANUAL TOMAX AST

Function: The Tomax Anti Stick-slip Tool (AST) stabilizes drilling torque through a mechanical process where excess loading and resulting spikes in torque causes the tool to contract along a set of internal helical splines. This contraction will effectively decrease the load and the depth-of-cut to prevent the onset of mounting oscillations. An internal spring is energized in the process to have the loading converge towards a continuous cut. Stick and slip effects in both longitudinal and torsional directions are common for all deep drilling operations. The reason is the long drill-string acting as a spring. A more predictable drilling operation with improved efficiency should always be expected with the AST.

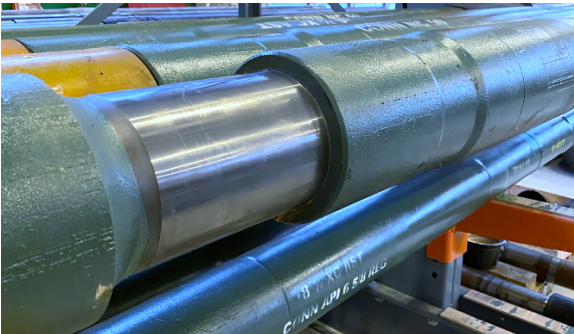
Illustration A

Handling: The AST unit is robust and cannot be damaged by standard pipe-handling equipment. However, under no circumstances should any handling tools or equipment be used on the chromed surface of the telescopic extension (Illustration A).

- ☐ Wipe the polished section of the telescoping mandrel and check for oil / mud leakage.
- ☐ Check the same, polished section for mechanical damage.

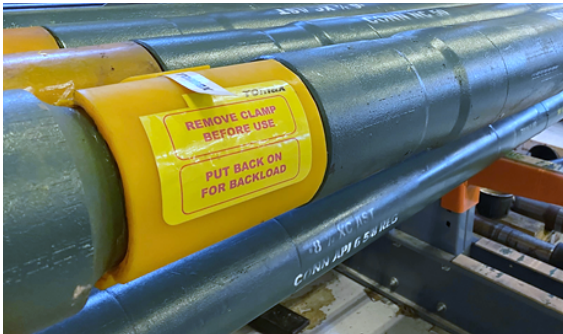
Illustration B

The AST is fitted with a yellow protective transport clamp (Illustration B). Remove the clamp before picking up the tool and replace it when the tool is laid out. Do not run the clamp into the well. Do not keep the clamp on while the AST is made up in the BHA or racked in the derrick, as it could be a potential falling object hazard if it should come off the tool. Please return the tool with both thread protectors and the protective transport clamp.

Protective clamp (all elastomer)

CAUTION 3: Remove the protective clamp (Illustration B) before the AST is made up in the BHA.

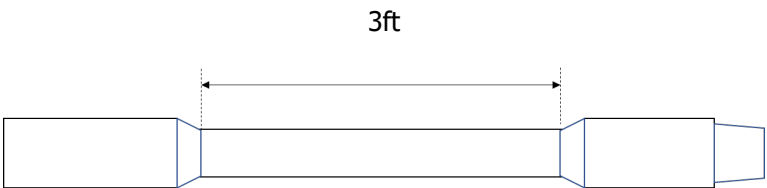
Illustration C - Minimum length of flexible sub/flex-wate is 3 ft

PDM DRIVEN RSS ASSEMBLY: The AST may be placed below the PDM in a motorized RSS assembly. Always consider the risk of fatigue. A flex-wate or flexible sub between the motor and the AST is recommended. See Illustration C.

HIGH CURVATURE (DLS) WELLBORES: In applications where the doglegs exceed the specified Endurance Dogleg Limit, there **MUST** be flexible joints (Illustration C) above and below the AST. The purpose is to increase the fatigue-life of the tool.

ENDURANCE DOG-LEG LIMIT	NON-ROTATING DOG-LEG LIMIT
<i>Below this limit, fatigue is not an issue. Above this limit, fatigue damage will occur, and mitigation is needed to reduce the damage; use flexible sections (Illustration C) to reduce stress. Also limit operating hours – see “Lay-out Criteria” in this manual.</i>	<i>This limit should not be exceeded. Fatigue failure may occur after a few rotations. For actual limits, see fact sheet at tomax.no/products.</i>
